INVENTORY FORM FOR STATE HISTORIC SITES SURVEY

HA-130B

Hiddenbrook Barn

522 Thomas Run Road

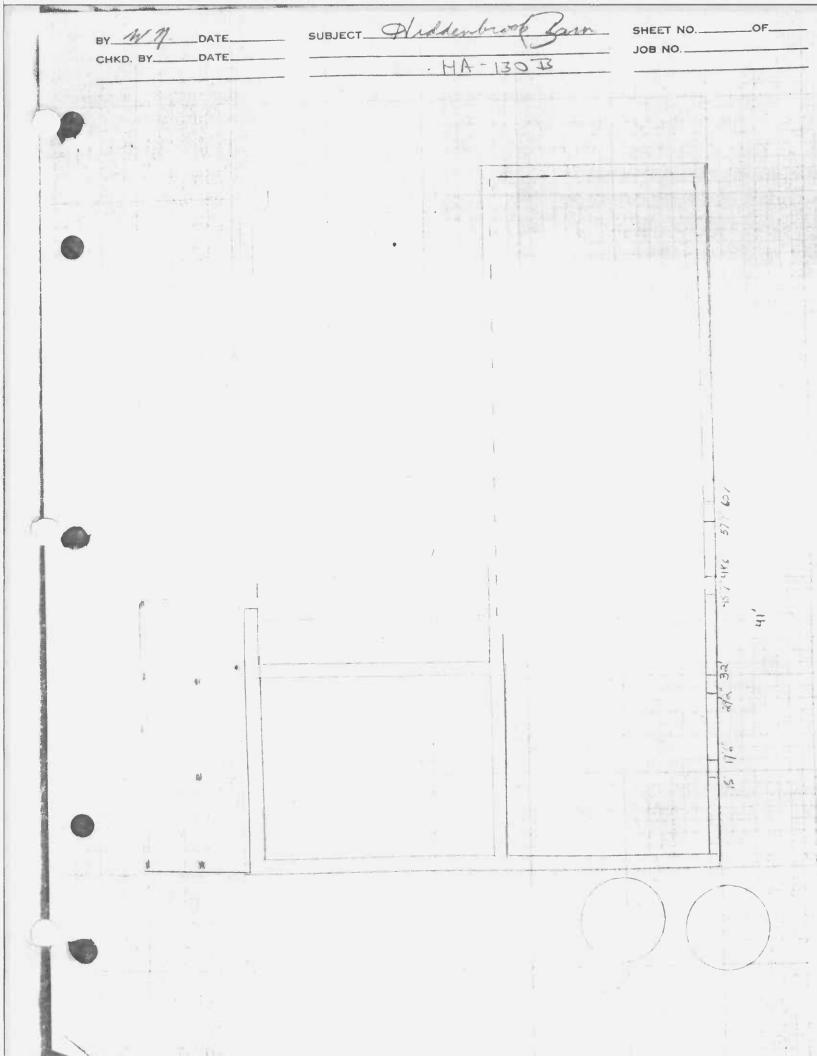
BY N.7. DATE 6/9/10 SUBJECT HIDDENBROOK BARN SHEET NO. OF SECTION 14

In general, however, it can be said that in the room formed by A & B together there are seven framing sections and they all employ post-and-beam construction with the hewn structural members ranging in thickness from 8" - 11". Each bent rises to heavily braced purlin posts supporting purlins that, like the rafters, are scarfed to run the length. Common rafters are notched to fit the plates rest on the purlins and are metered at the ridge.

U. END BENT HA-130 B

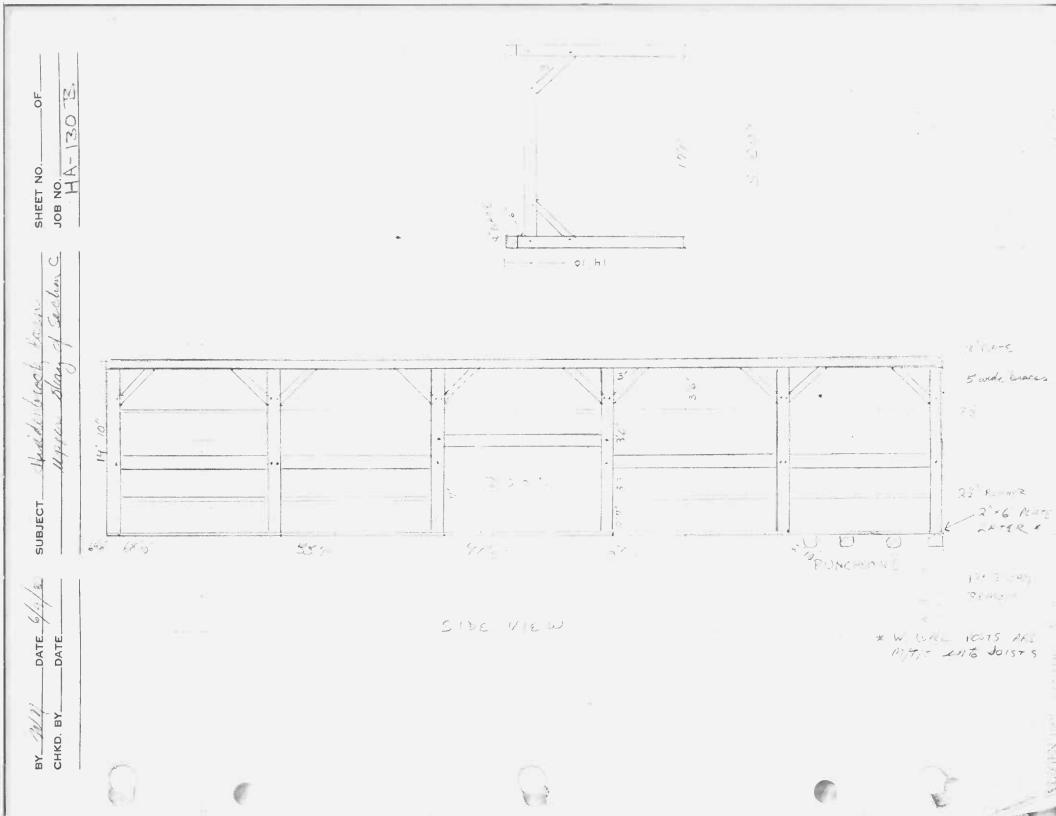
BY W.7 DATE 5/6/80 SUBJECT Hidenbrook Parn SHEET NO.____OF__ CHKD. BY____DATE_ JOB NO.__ W. < 178'6" Α. ENLOSED GRAIN THAT FORM С.

It is concluded that the complex began with Section A, a.c. 40' X 60' bank barn utilizing stone and post-and-beam construction. That building was extended 36' to the west and then a c. 24' X 70' south wing was added that also employs post-and-beam framing (although of a different sort). In modern times (but prior to the 1960's) the section had its lower east wall removed and was extended 14' in that direction making area "C." It is a modern milking room.

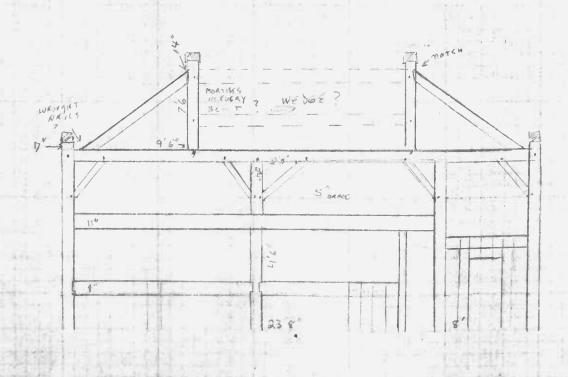
BY W. M. DATE \$/6/80	SUBJECT Heddenhead Barn	SHEET NOOF
CHKD. BYDATE	BENT #Z	JOB NO
	MA-130 B

Cut siding nails along the tie-beam of bent #4 and the stone wall below show that this was the original west end. This fact explains the absence of purlin braces on the bent as it matches the framing of the east end.

7 BENTS E+W

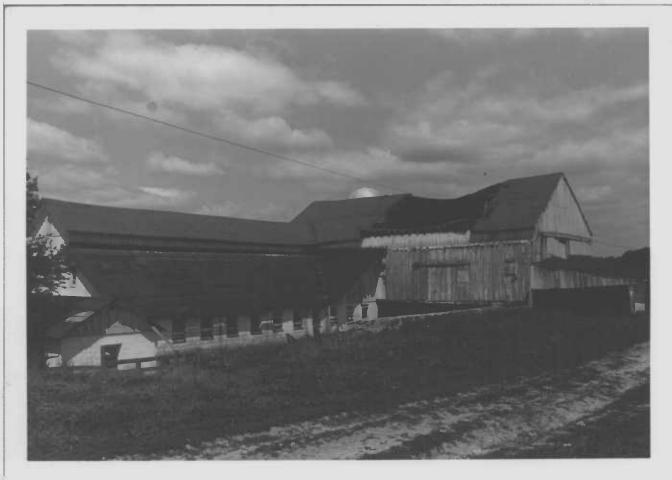
HA-130B Hidden Brook Barn (Demolished 11/80) Churchville, Maryland Wayne Nield II 6/80 Southeast

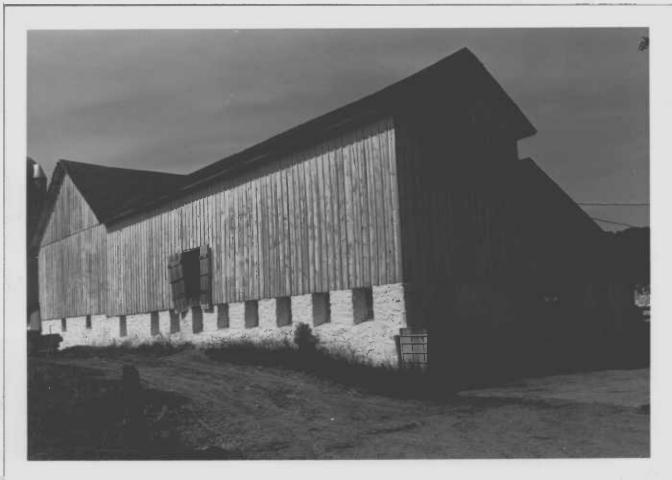
HA-130B Hidden Brook Barn (Demolished 11/80) Churchville, Maryland Wayne Nield II 6/80 Southwest

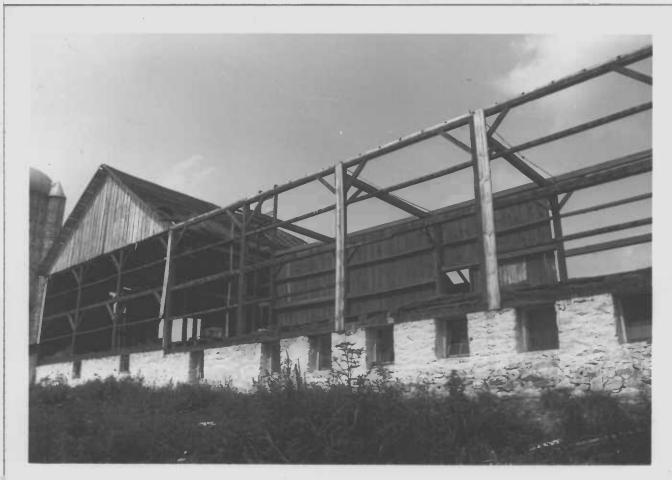
HA-103B

The original east end of the building is now covered by a post supported shed that extends out from the building about 18'. The posts are a mixture of tree-posts and re-used dressed beams.

Hidden Brook Barn - Demolished Bel Air, Md. Wayne L. Nield II 6/80 East

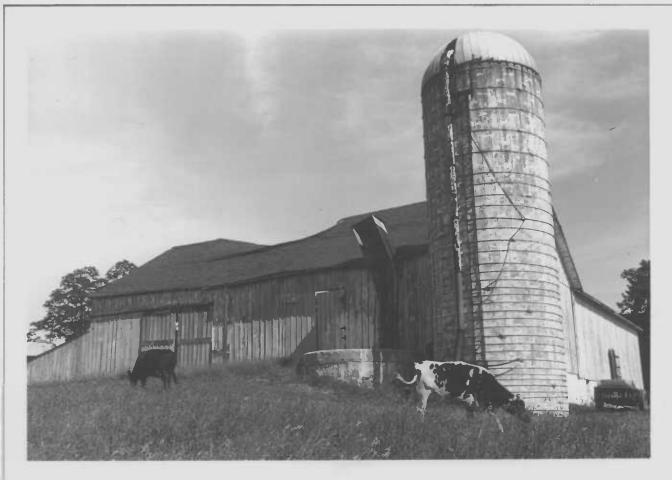
The north side of the barn is the bank side with the shed. It is over 96' long broken only by two large doors and the ground level windows of the lower level. The doorways are not of equal size and appear asymetrical. The north door is the original location of a centire door of section "A" and the south door belongs to addition "B". The north door is 16' wide and high and mounted with modern rollers. The south doorway, however, is 10' 9" wide, high and has double doors mounted with a mixture of hinges including forged loop-end straps.

HA-130B Hidden Brook Barn (Demolished 11/80) Churchville, Maryland Wayne Nield II 6/80 North

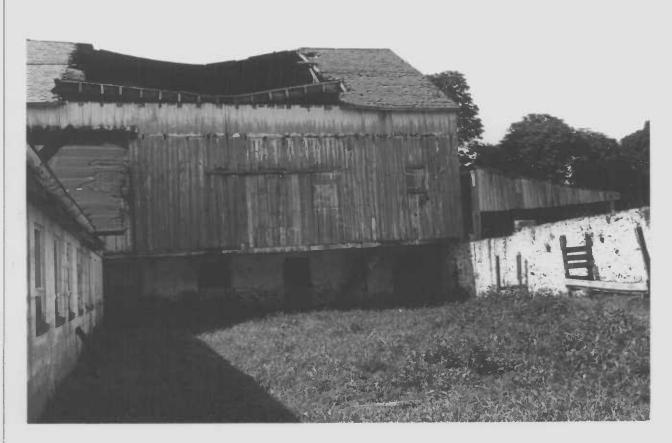
HA-130B

The most difficult to describe facade is the south side. Its features alone reflect the multi-faceted purpose of the building. The east wall is extended over 60 feet to form a 7'6" high wall that along with the south extension formed an enclosed barnyard. The cantilevered overhang makes for a semi-enclosed shelter that receives maximum light in winter. The lower level contains your stall doors (3' wide) and is designed to accommodate animals. The present doors are "Dutch doors designed as picket gates. They are put together with cut nails and some are still hung with forged loop-end strap hinges mounted on pinnels. It can be seen in this area that the cantilevers are thick puncheons nearly a foot wide (11" average). This overhang contains storage space for grains but on the outside one can see evidence that there was once a large double width loading door. There are two smaller solid shutter windows on either end of the facade. These are 2'6" x 3', are irregularly placed and are hung with spade-end strap hinges. It can also be seen that there was once a shed covering the lower area perhaps or at least a pent. Beneath the flashing line left from that structure there is also evidence of that area having been painted red while the rest of the structure is now painted white.

Hidden Brook Barn (Demolished 11/80) Churchville, Maryland Wayne Nield II 6/80 South

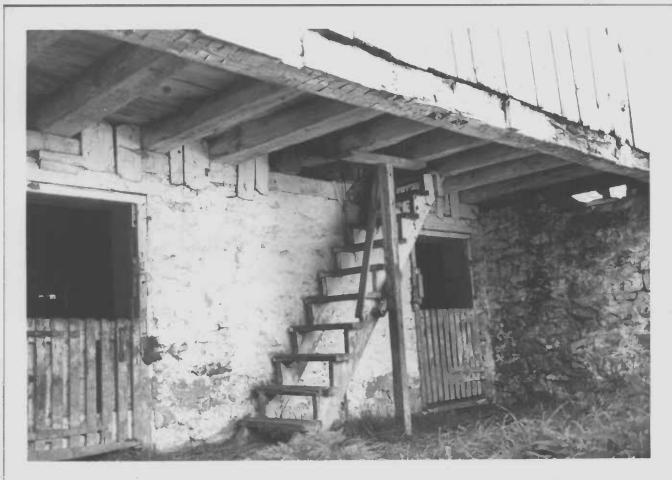
HA-130B Hidden Brook Barn (Demolished 11/80) Churchville, Maryland Wayne Nield II 6/80 South

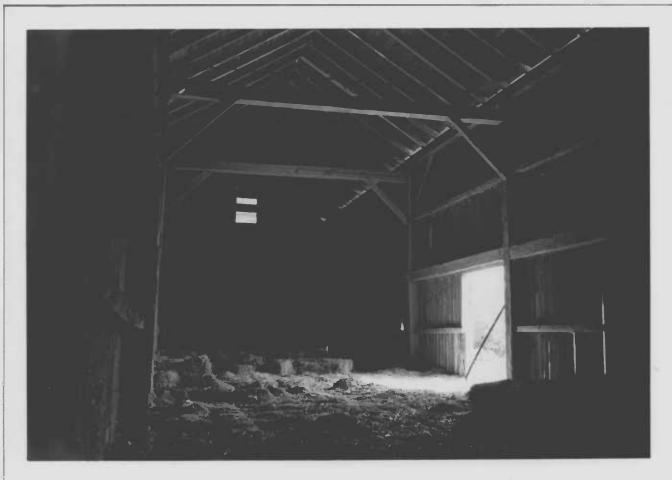
The original west end of "A" is covered by "B", however, inside it can be seen that there was a central end doorway and transom with windows on either side that had diamond shaped horizontal bars. The present west side of the complex is the longest being 110'6" in length and incorporating walls of both sections "B" and "C". It is typified by its windowless board-and-batten upper story and its lower stone portion with its minimum windows. There are eleven windows along this side. Three of them belong to section "A" and the rest are clustered in "C". It is believed that they facilitated corresponding milking stalls within.

HA-130B Hidden Brook Barn (demolished 11/80) Churchville, Maryland Wayne Nield II 6/80 Doors-west elevation

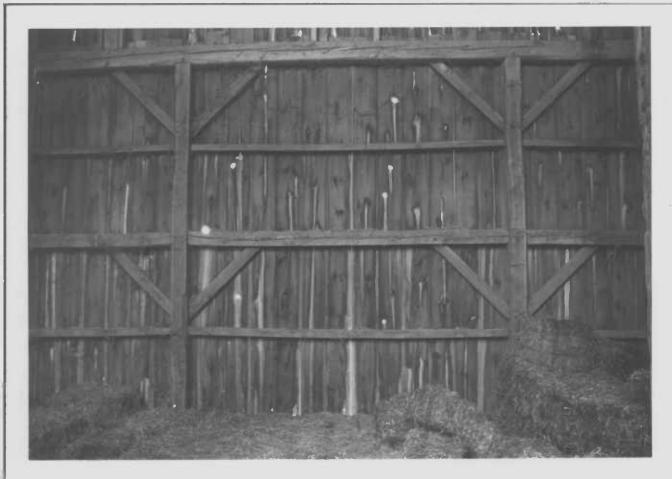
HA-130B Hidden Brook Barn (Demolished 11/80) Churchville, Maryland Wayne Nield II 6/80 West Gable End

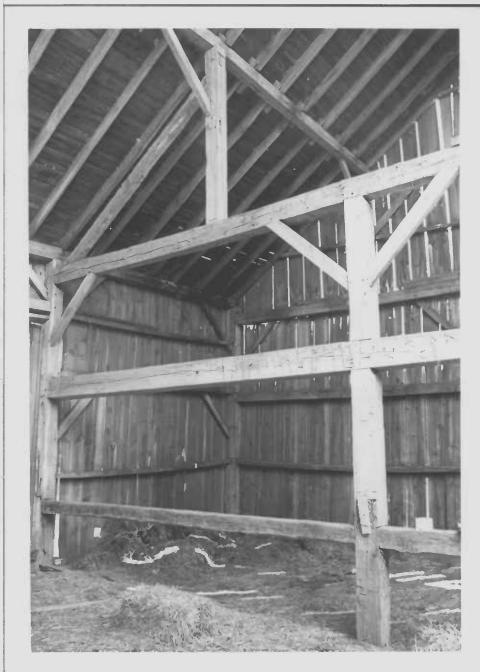
A bent and twisted track to a hay fork runs along the ridge and is in fact the thing holding up the rest of the partially collapsed slate roof.

HA-130B Hidden Brook Barn (demolished 11/80 Churchville, Maryland Wayne Nield II 6/80 Interior

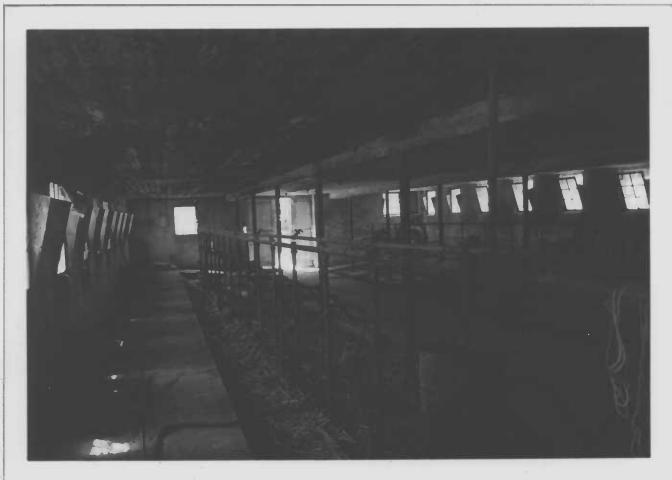
The fenestration of the west wall is not unlike that of the newer concrete block wall on the east, suggesting that this area has long been used for lining up 20 cows or so for milking. A modern shed roofed addition widened this area by nearly 50%. That alteration destroyed the original walls of the north and east sides. The present floor is cement with wash down troughs built in, as well as head lock stalls made of piping.

HA-130B Hidden Brook Barn (Demolished 11/80) Churchville, Maryland Wayne Nield II 6/80 Interior of South Wing

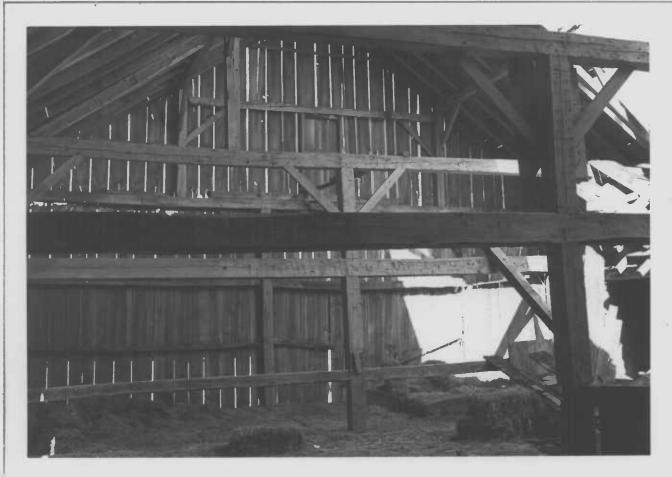
HA-130B Hidden Brook Barn (Demolished 11/80) Churchville, Maryland Wayne Nield II 6/80 East Gable End

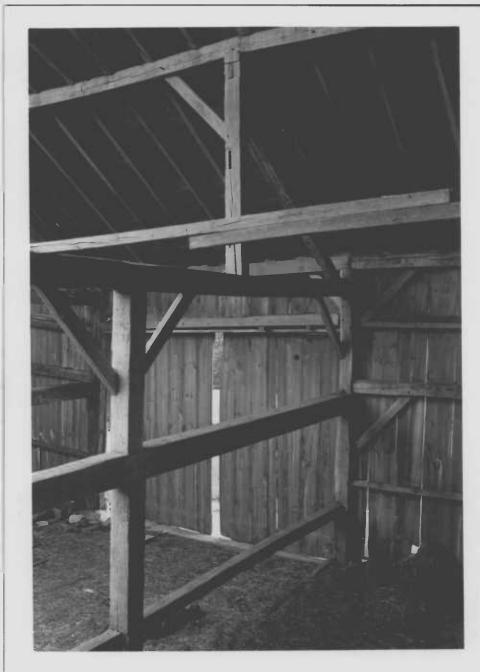
HA-130B Hidden Brook Barn (Demolished 11/80) Churchville, Maryland Wayne Nield II 6/80 Doors-North elevation

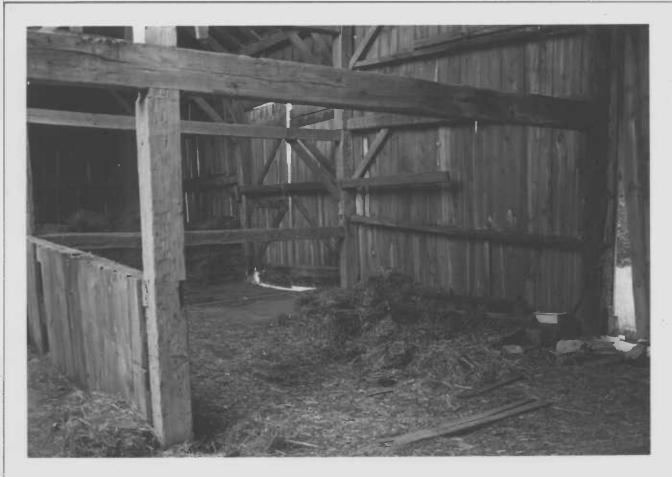
HA-130B '
Hidden Brook Barn (demolished 11/80)
Churchville, Maryland
Wayne Nield II 6/80
Interior - north elevation
